NUMBER: 18-054-15

Mil Illumination: P2453,P2454,P2455 or P2463 Active or Stored

This bulletin involves determining if the Differential Pressure Sensor and its Connector require repair.

2010-2015 (RT)

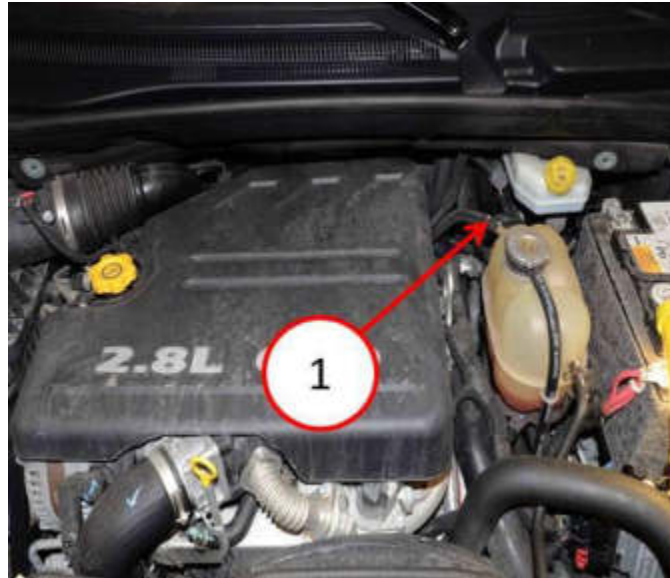
Fig. 1 Differential Pressure Sensor Location - Engine Compartment Location

1 -Differential Pressure Sensor Location

1. Disconnect the negative battery terminal.
2. Disconnect the Coolant Bottle and reposition it to reach the Differential Pressure Sensor (DPS) ([Fig. 1](#)).

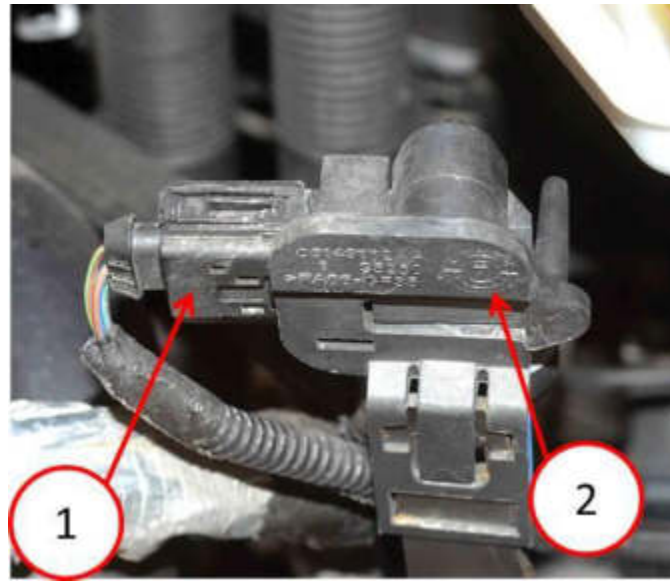
Fig. 2 Differential Pressure Sensor

3. Disconnect the differential pressure sensor harness connector and check for oxidation ([Fig. 2](#)).

- 1 - Differential Pressure Sensor Harness Connector
- 2 - Differential Pressure Sensor

-
4. Are the terminals oxidized/ corroded ?
 - a. Yes. >>> Proceed with [Step #5](#).
 - b. No. >>> This bulletin does not apply. Normal Diagnostics should be performed.

NOTE: Normal inspection methods may not uncover the type of corrosion present (fretting).

5. Disconnect the differential pressure sensor hoses.
6. Release the clips and remove the differential pressure sensor.
7. Using the Wiring Kit, P/N 68080561AA ([Fig. 3](#)), replace the existing 3 way connector and terminals with the new components from the kit which will be complete with silver plated terminals. To complete the Service Procedure only the white wires are necessary. Refer to the detailed service procedures available in DealerCONNECT> TechCONNECT under: Service Info>29- Non DTC- Diagnostic>Circuit Testing Procedures>Standard Procedure>Wire Splicing.

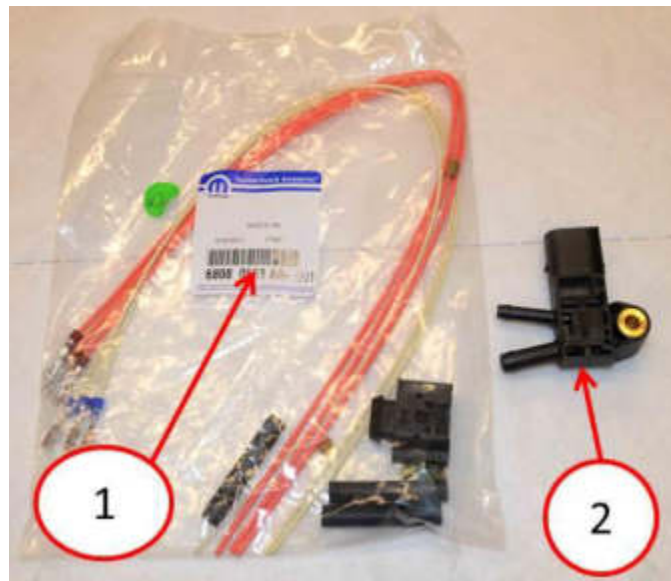
Fig. 3 Parts Required

- 1 - P/N 68080561AA - Wiring Kit
- 2 - P/N 56044587AB - Sensor
